APPENDIX C

**BLDG. 1003
PHOTOGRAPHS, EVALUATION, SEISMIC ANALYSIS,
DEFICIENCIES AND COST**

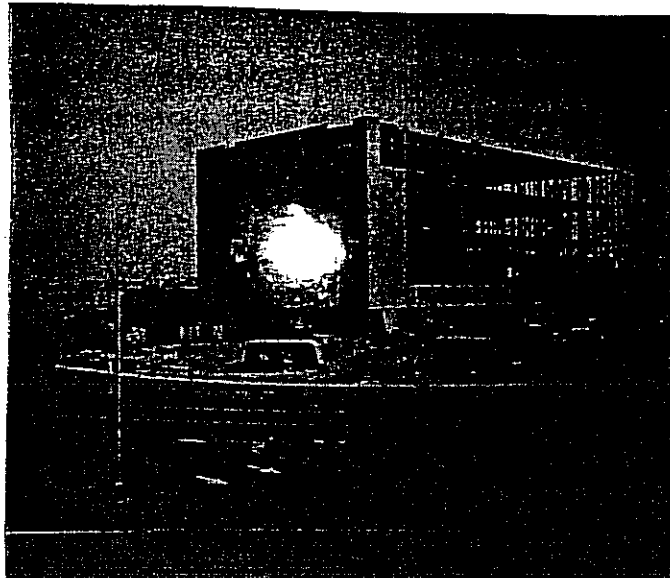
Photo 12. Existing photograph of the failure of a gusset plate following the 1989 Loma Prieta Earthquake. The failure is located in the cracked plate at the joining of a diagonal brace to the column. This was discovered accidentally during the reconstruction of a third floor bathroom. The crack was repaired but there is no information on whether a study was performed to inspect and evaluate all other similar connections in the building.

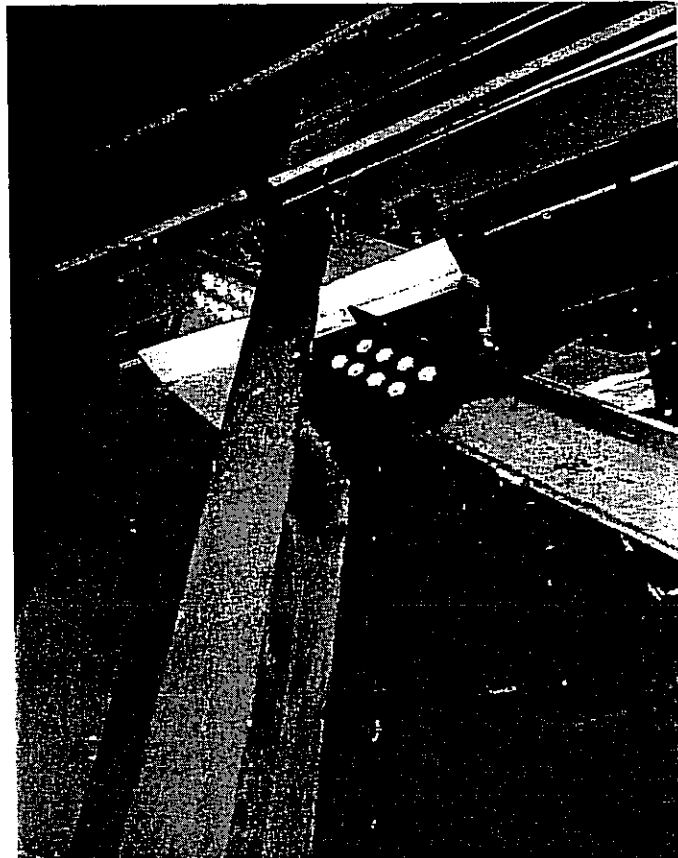
Photo 20. Typical connection of floor beams to column top. Notice the connection is not designed as a moment resistant connection. The steel deck floor is tack welded to the floor joist.

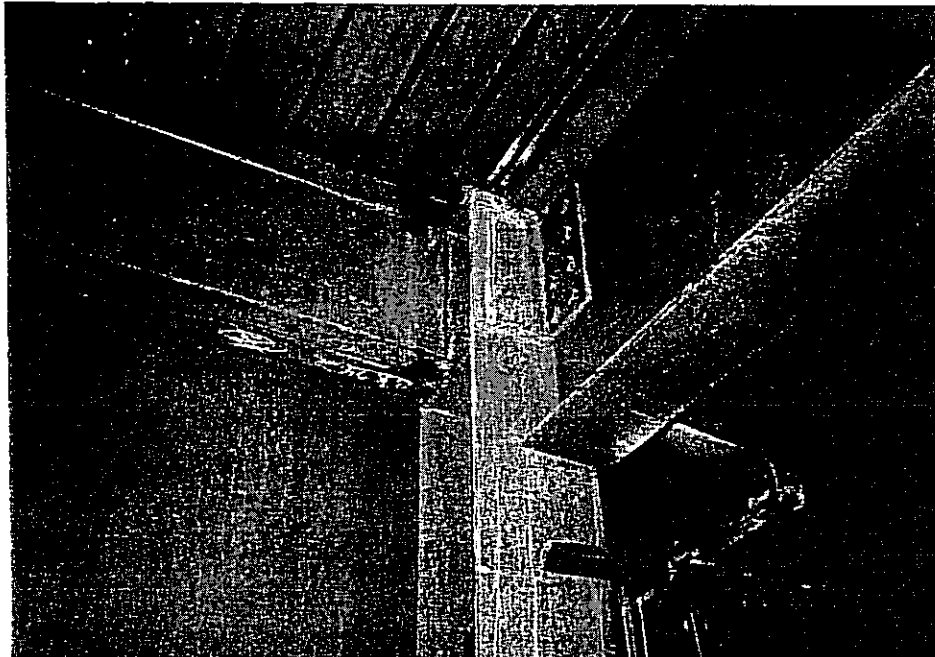
Photo 22. Another view of the connection of floor beams to column top. Again, notice the connection is not designed as a moment resistant connection.

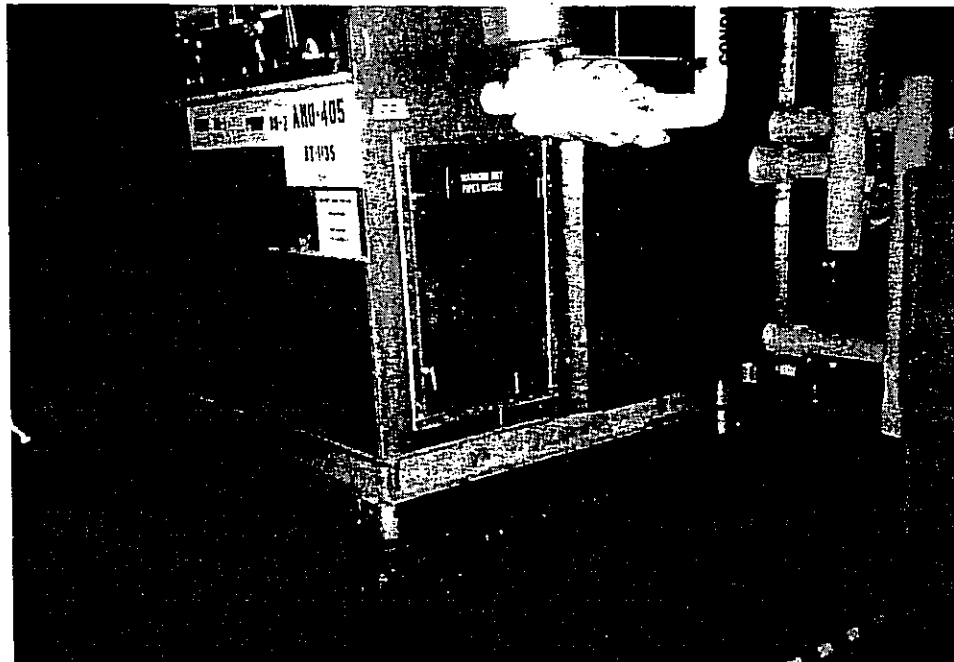
Photo 31. View of different type of anchorage for the mechanical equipment. This one is a rigid anchor type with no allowance for vibration. It connects the equipment rigidly to the foundation.

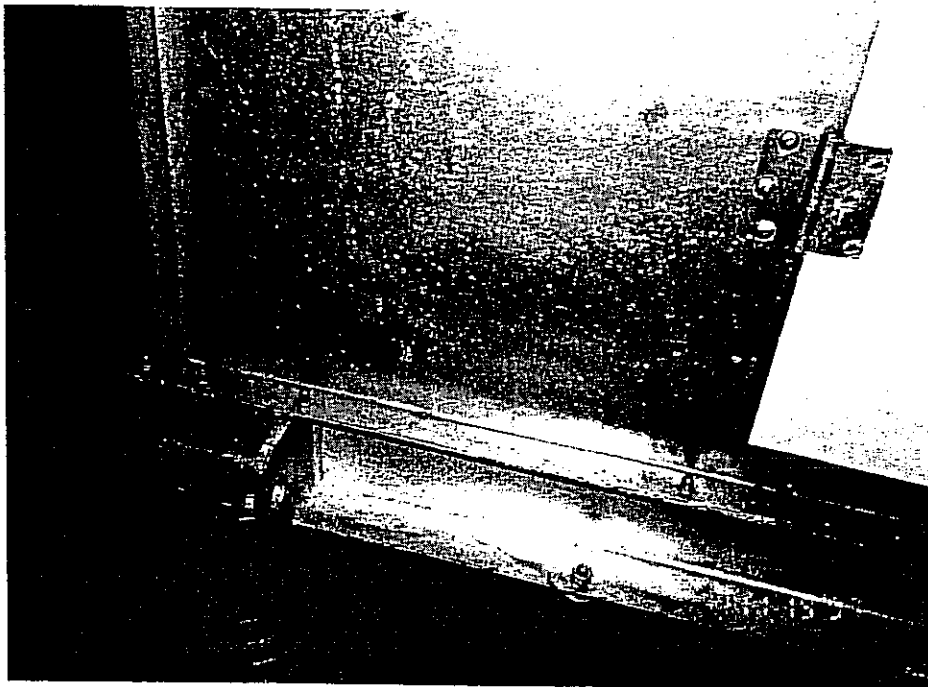
Photo 33. This other type of anchorage for the mechanical equipment provides vibration isolation and allows lateral restraint with a dampening effect. This anchor type is recommended to limit horizontal and vertical motion while absorbing stresses to minimize damage to equipment, piping connections or foundation.

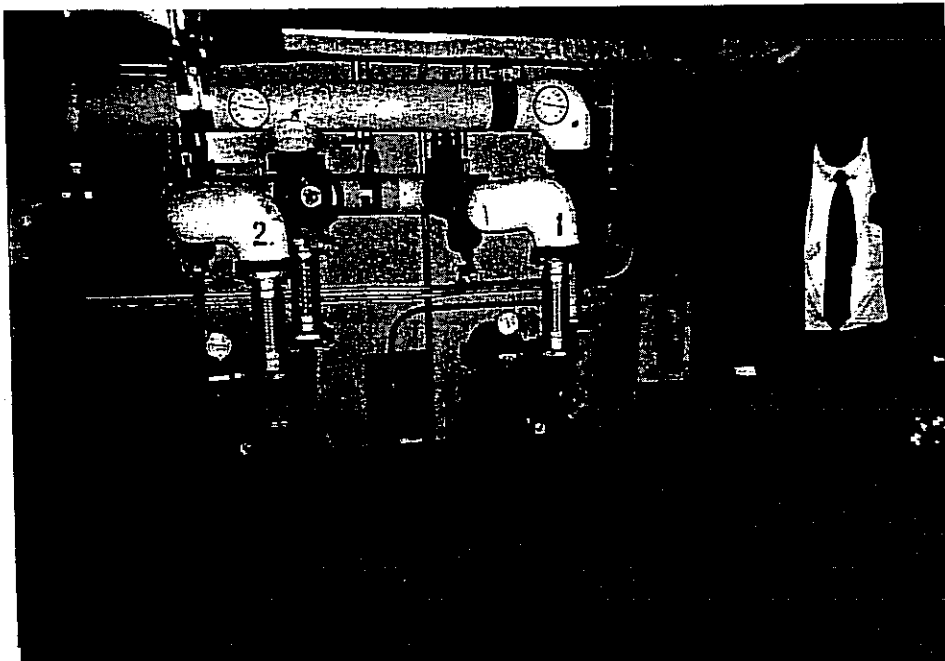
Photo 47. Some pipe crossing through walls do not have flexible joints or sleeves with tolerance for movement. Fire blocking is appropriate but tolerance for movement should be included.

Unseal firewalls	low hazard	could readily be fixed
No pipe flexible joints	low hazard	could readily be added

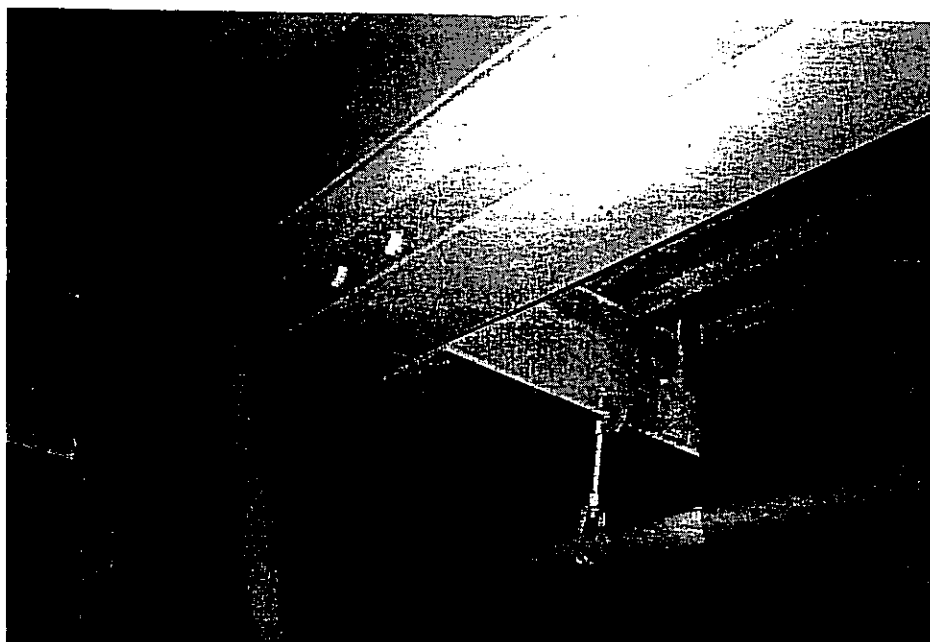
Photo 49. Some equipment supports at the roof level are rigidly anchored to the roof structure. Lateral bracing in both directions is recommended for legs supporting equipment over 18 inches above floor level.
